ENGINE—ENGINE OIL LEVEL INDICATOR MARKINGS—REPORTS OF LOW OIL LEVELS

Article No. 03-8-3

FORD: 2002 ESCORT

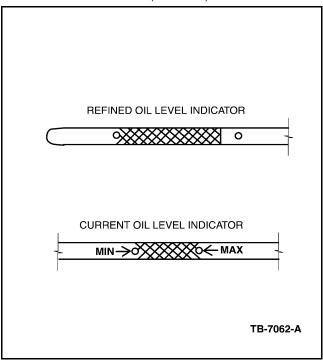
Figure 1 - Article 03-8-3

Ford is in the process of standardizing the markings across all vehicle lines. Current markings shown will be upgraded to a refined marking, shown in Figure 1. Both markings will be used in production over the next few years. Oil levels will still be recorded in the crosshatched area of the blade, between the upper and lower limit holes. Vehicles shipped with engine oil levels falling within this area are acceptable and do not require topping off. Oil fill quantities are precisely measured at the plants and account for slight variations that may occur in oil pan volumes, indicator length, and pressed-in locations of the indicator tube into the block. For customer use, the markings continue to serve as a guide to refilling the engine to the correct initial fill volume with filter or, to top off the engine when it is determined the level is below the lower hole.
